Construction and performance of six template groins at Hunting Island, South Carolina

Steven B. Traynum

Coastal Science & Engineering
P.O. Box 8056, Columbia, SC 29202
straynum@coastalscience.com

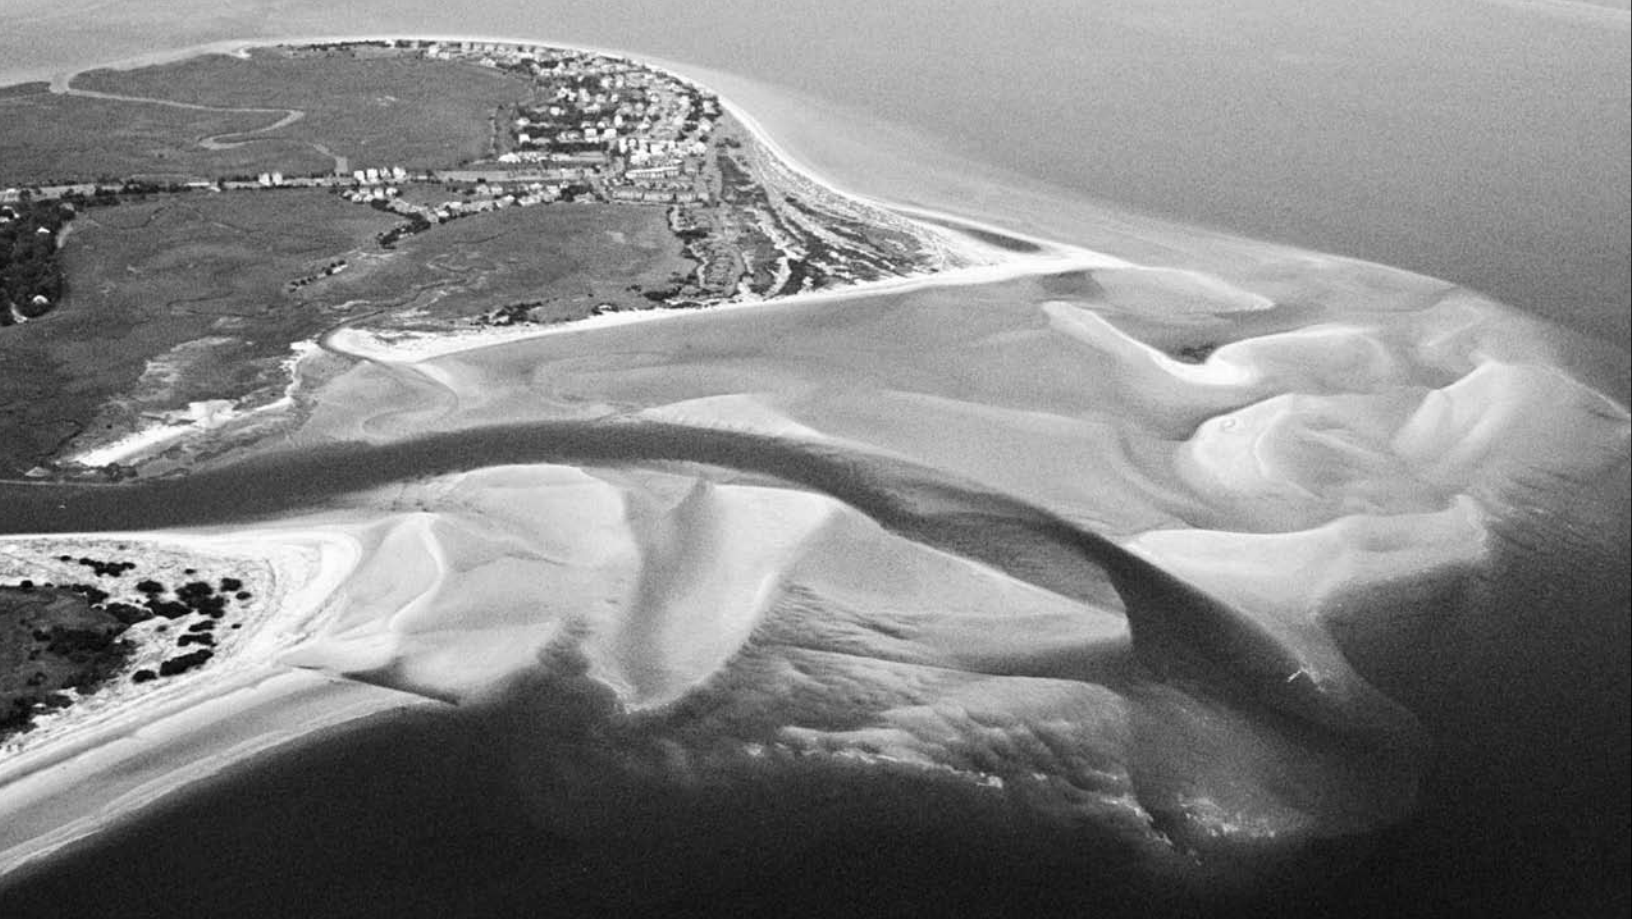
Figure 3. Oblique aerial photo at low tide on 10 February 2006, showing the exposed shoals of the Johnson Creek ebb-tidal delta which is estimated to contain ~20 million cubic yards. The northern spit of Hunting Island is at the lower left. A terminal groin was constructed at the end of the spit in 1969.

The analysis showed that these six groins, when combined with the existing terminal groin (Figure 3), have the potential to trap up to 690,000 cy over the applicable reaches (Figure 4). Excess sand would be placed to facilitate construction of the groins and would naturally feed downcoast areas after construction.

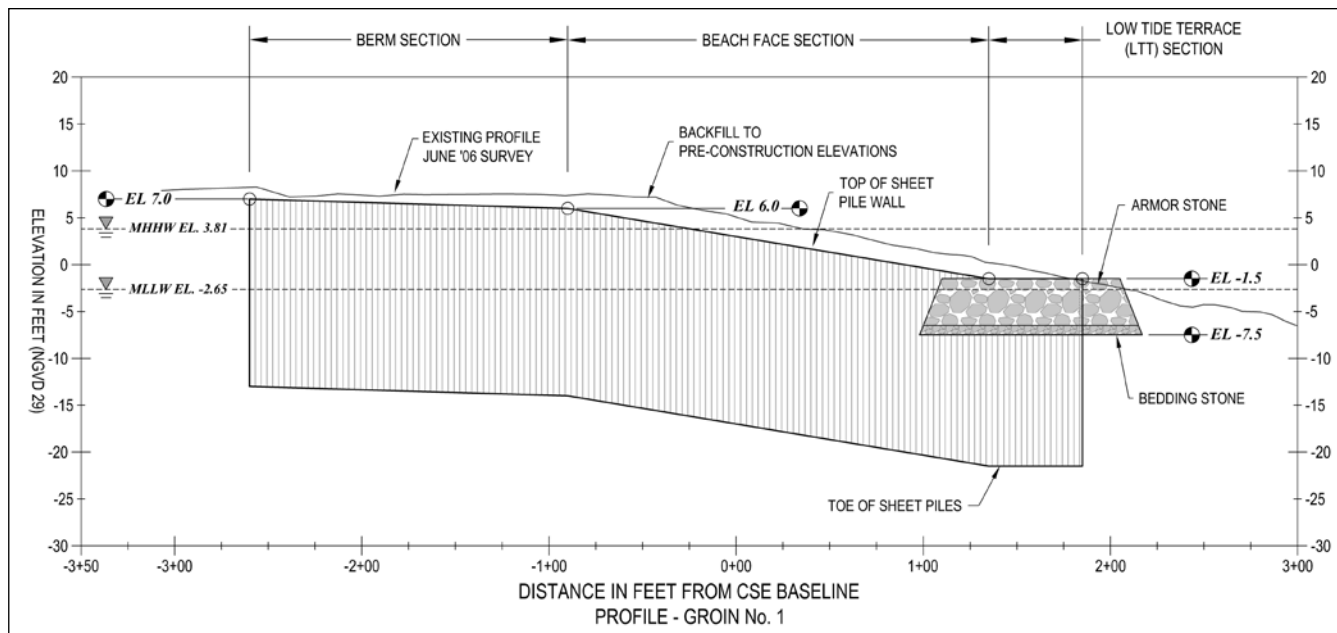
Figure 5. Construction plan for the sheet-pile Groin #1 in the Campground Reach. The berm and beach face sections are sloped to match the native profile of the beach. The low-tide terrace section is set at the local MLW elevation. Final design for each groin was completed after nourishment, as design depended on the condition of the beach after the fill was placed. (Courtesy: CSE unpublished construction documents.)

The berm sections ranged from 150 ft to 205 ft long with the crest of the sheet pile set between +7.0 ft NGVD at the landward end and +6.0 ft NGVD at the seaward end. The beach-face sections ranged from 225 ft to 231 ft long, sloping at approximately 1:30 to a seaward elevation of -1.5 ft NGVD. The low-tide terrace (LTT) section ranged from 34 ft to 75 ft long set at -1.5 ft NGVD. This latter crest elevation was established based on the local, mean lower low

water elevation of -2.65 ft NGVD so as to allow the contractor to drive piles and attach caps in the seaward section at low tide without the aid of a coffer dam. The Industrial Company (TIC–Savannah, GA) worked closely with CSE’s project engineer to develop a practical construction plan which used the local tide range and hard-packed sands of the intertidal zone to advantage.

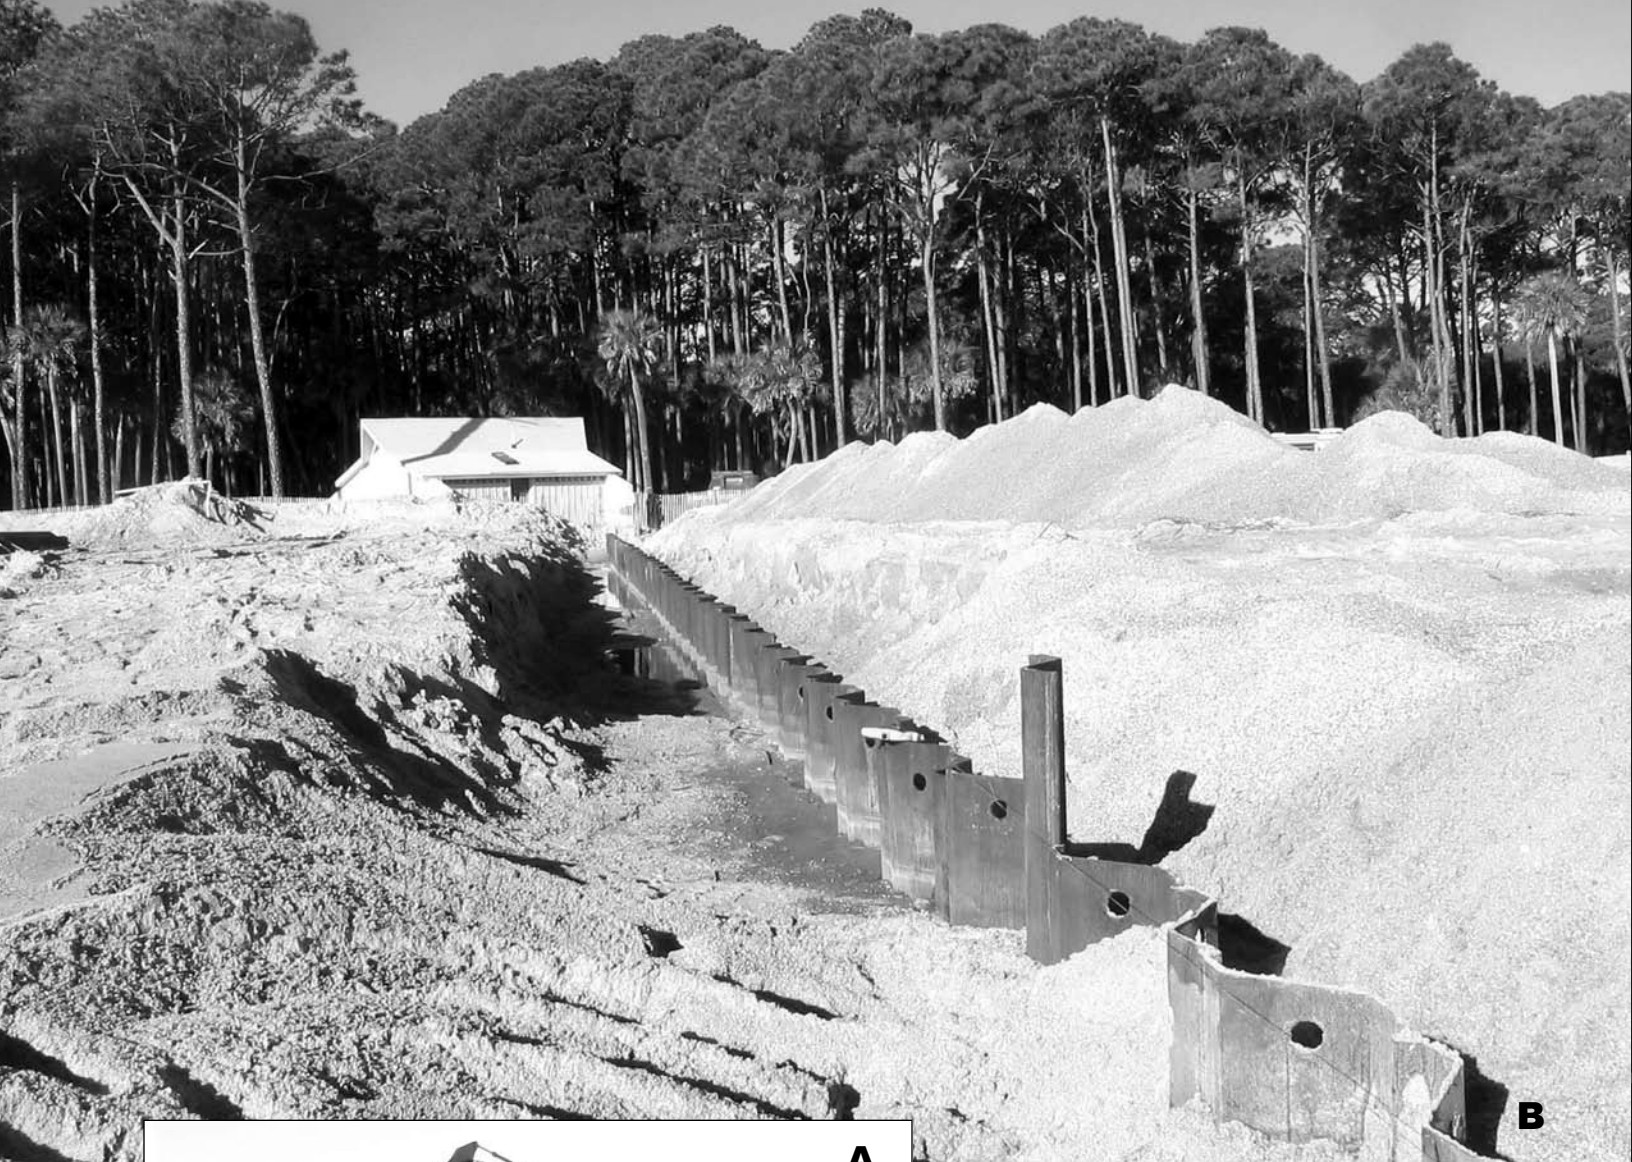
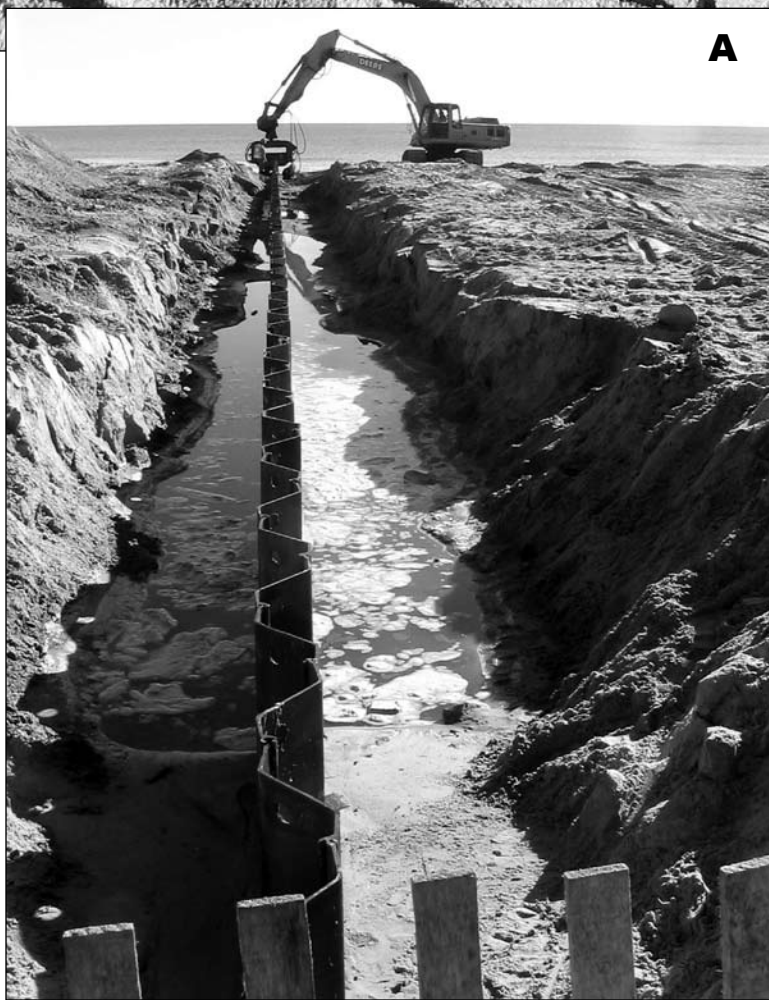
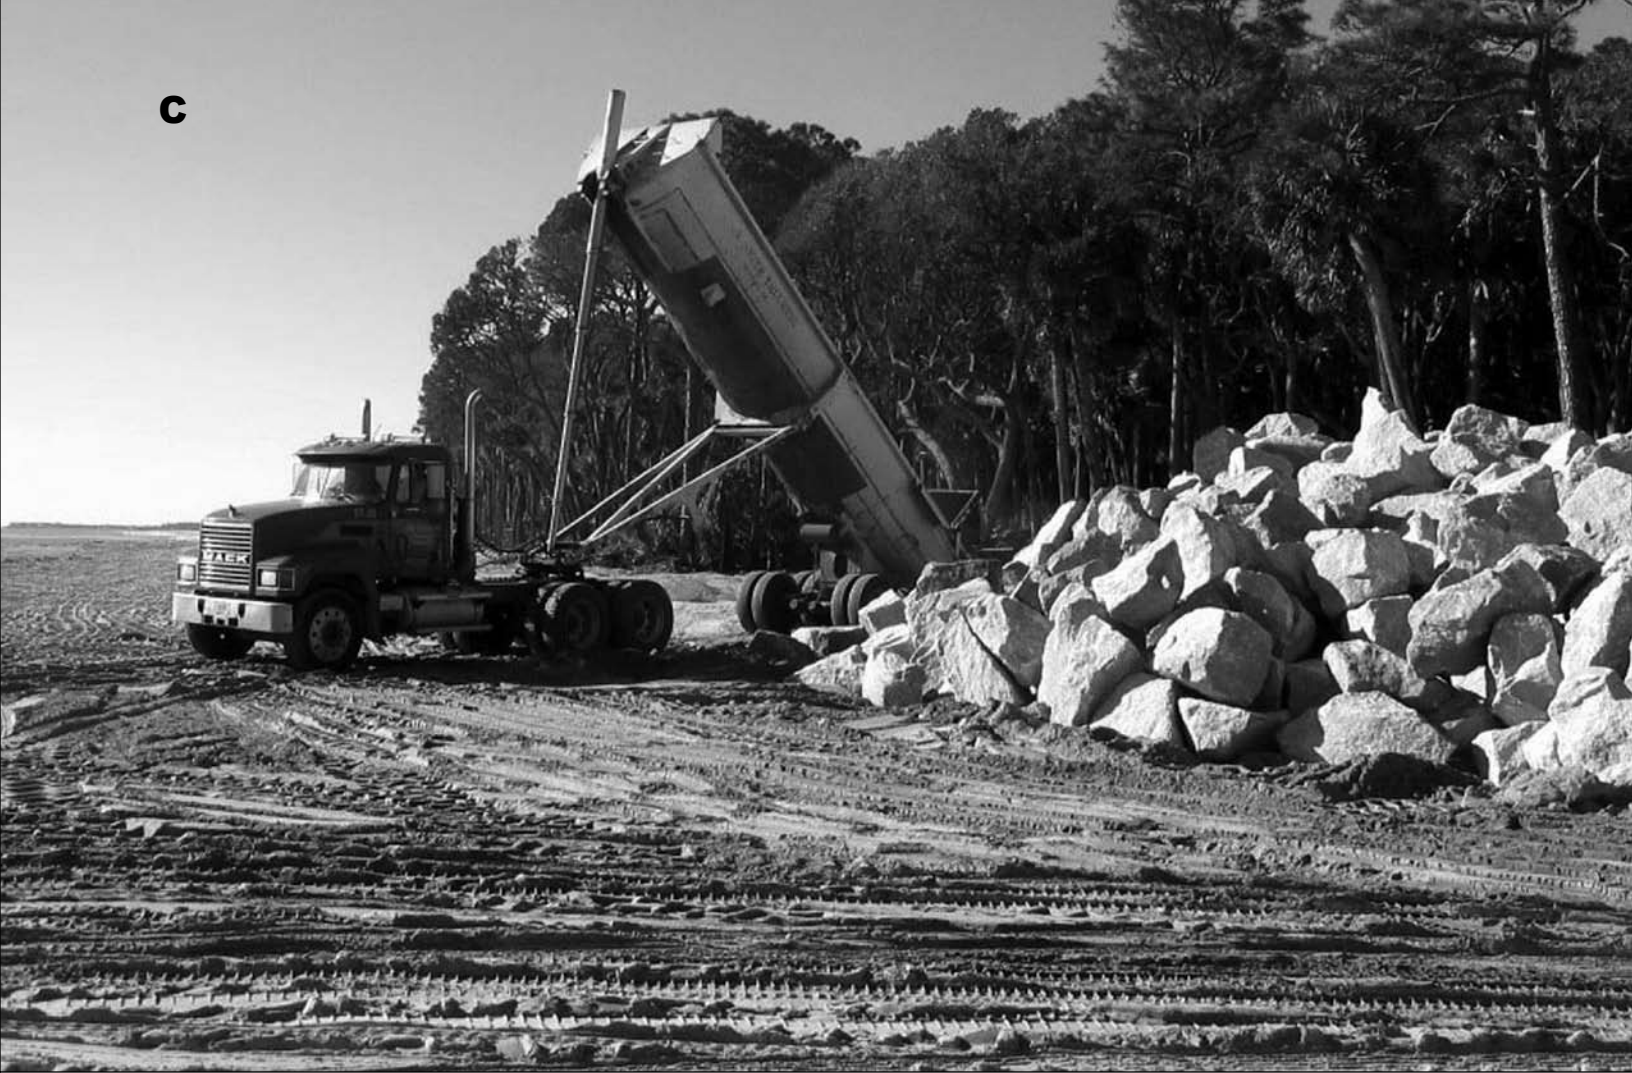
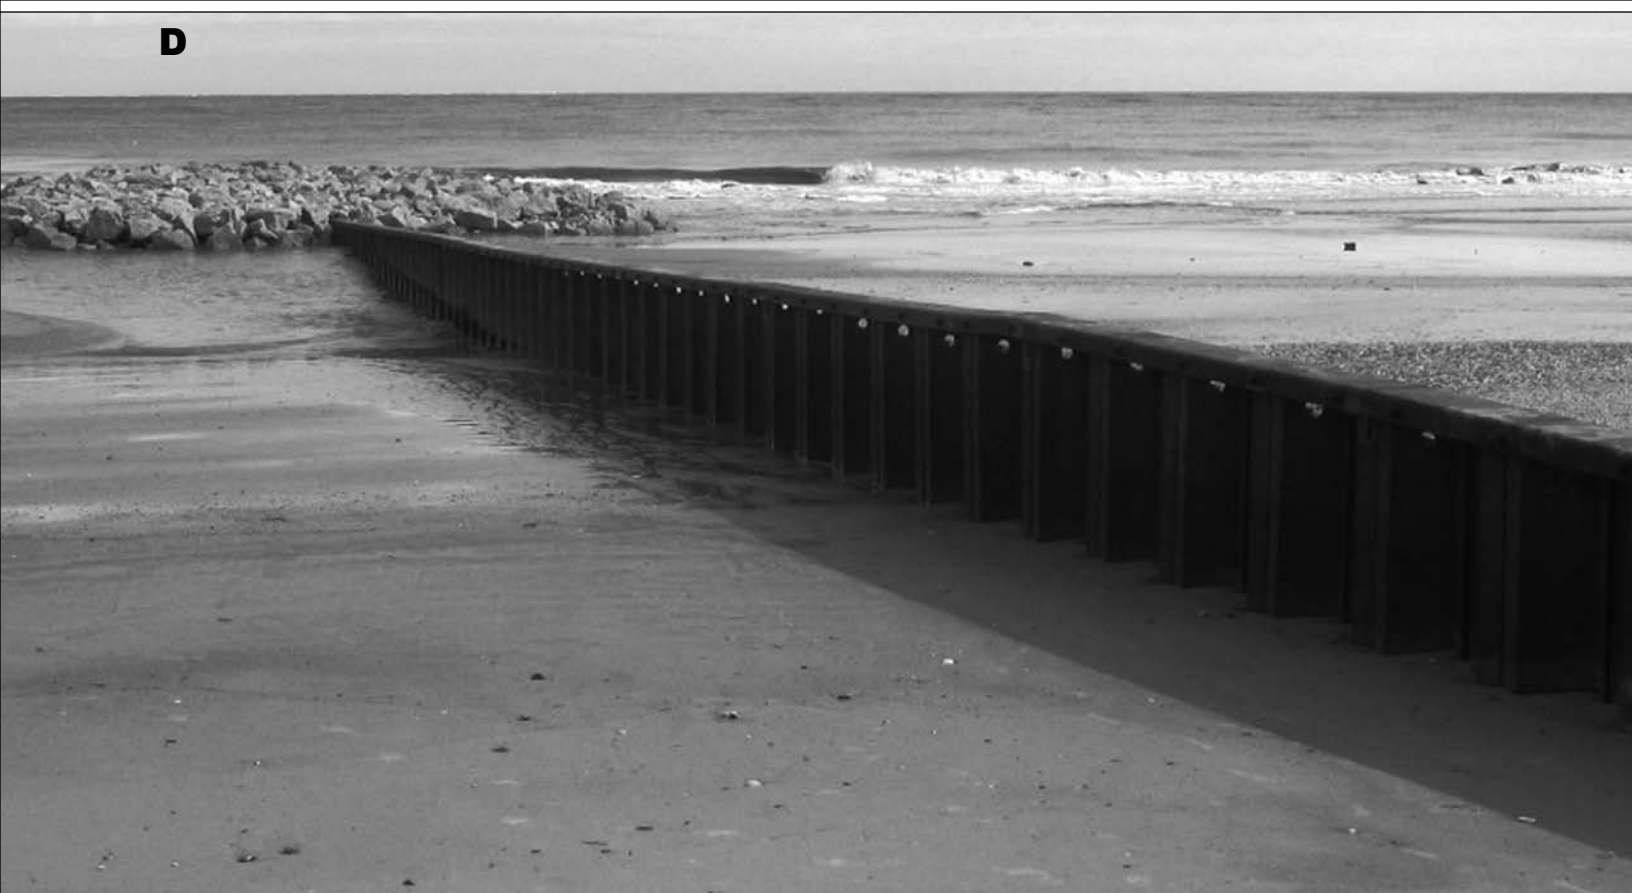
Figure 6. Construction photos of the groin installation project in January-February 2007. Steel sheet piles (20-ft long) were driven into the sand, following the natural profile of the beach (A and B). Armor stone was used for toe protection (C). Groin 2 at low tide in March 2007 (D).

Figure 6 presents representative photos of the construction. Minor modifications were made to the cap (steel channel) at the end of construction to improve its attachment. A combination of through-bolts, welded brackets, and spot-welding was used in the cap attachment. The project included signage and buoys marking the heads of the structures. Before and after aerial images are shown in Figure 7.

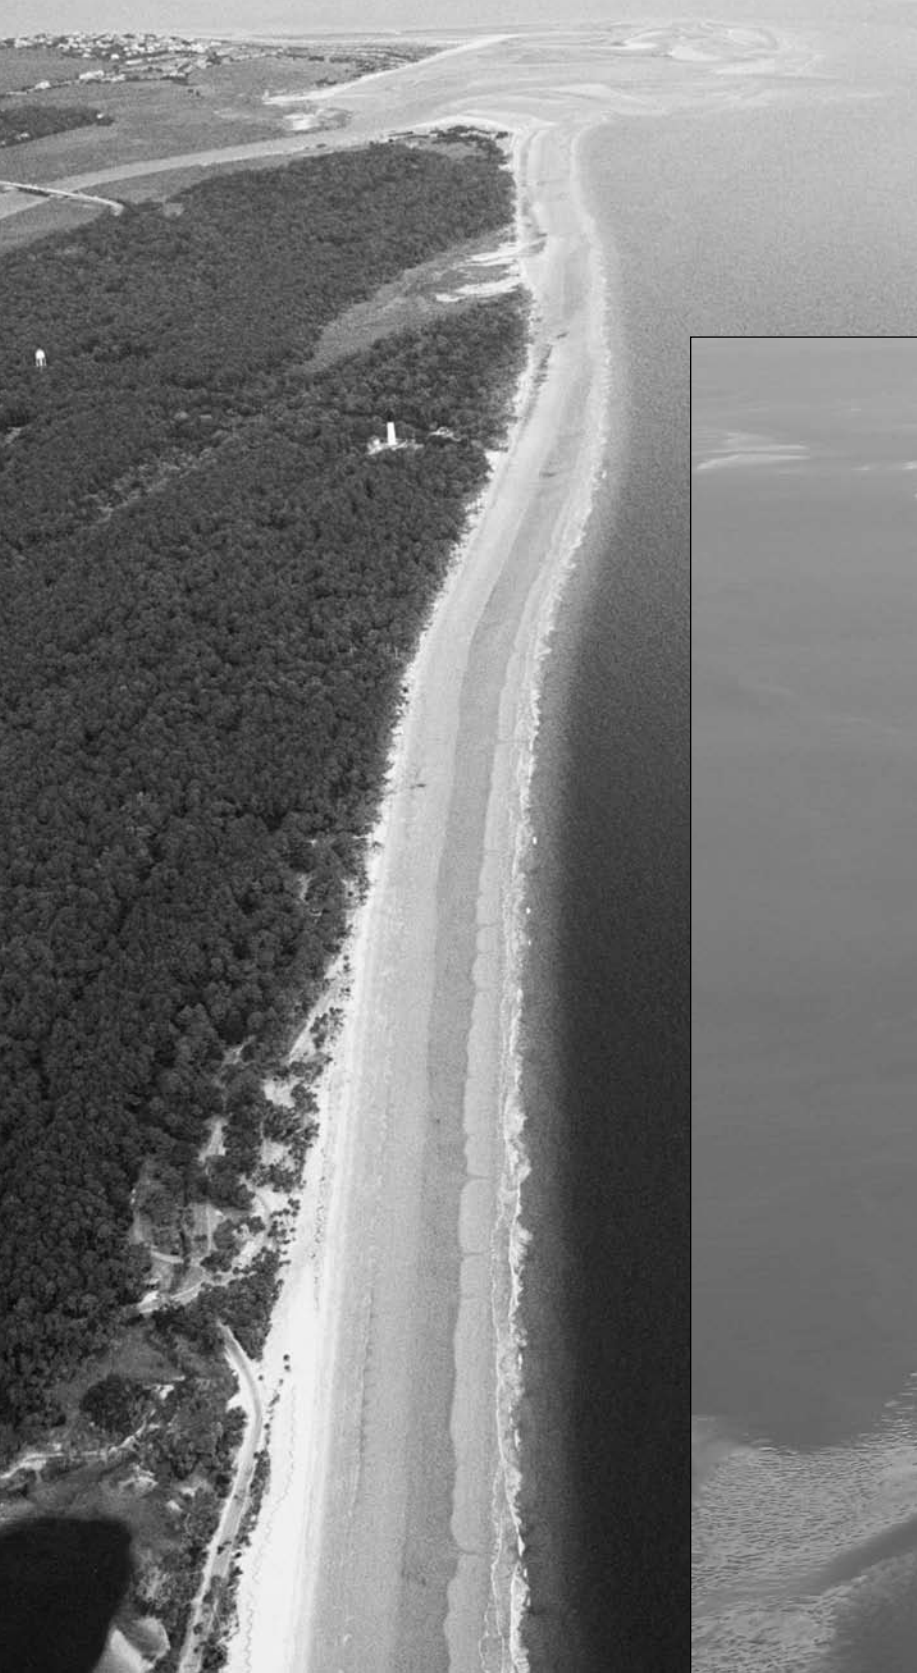
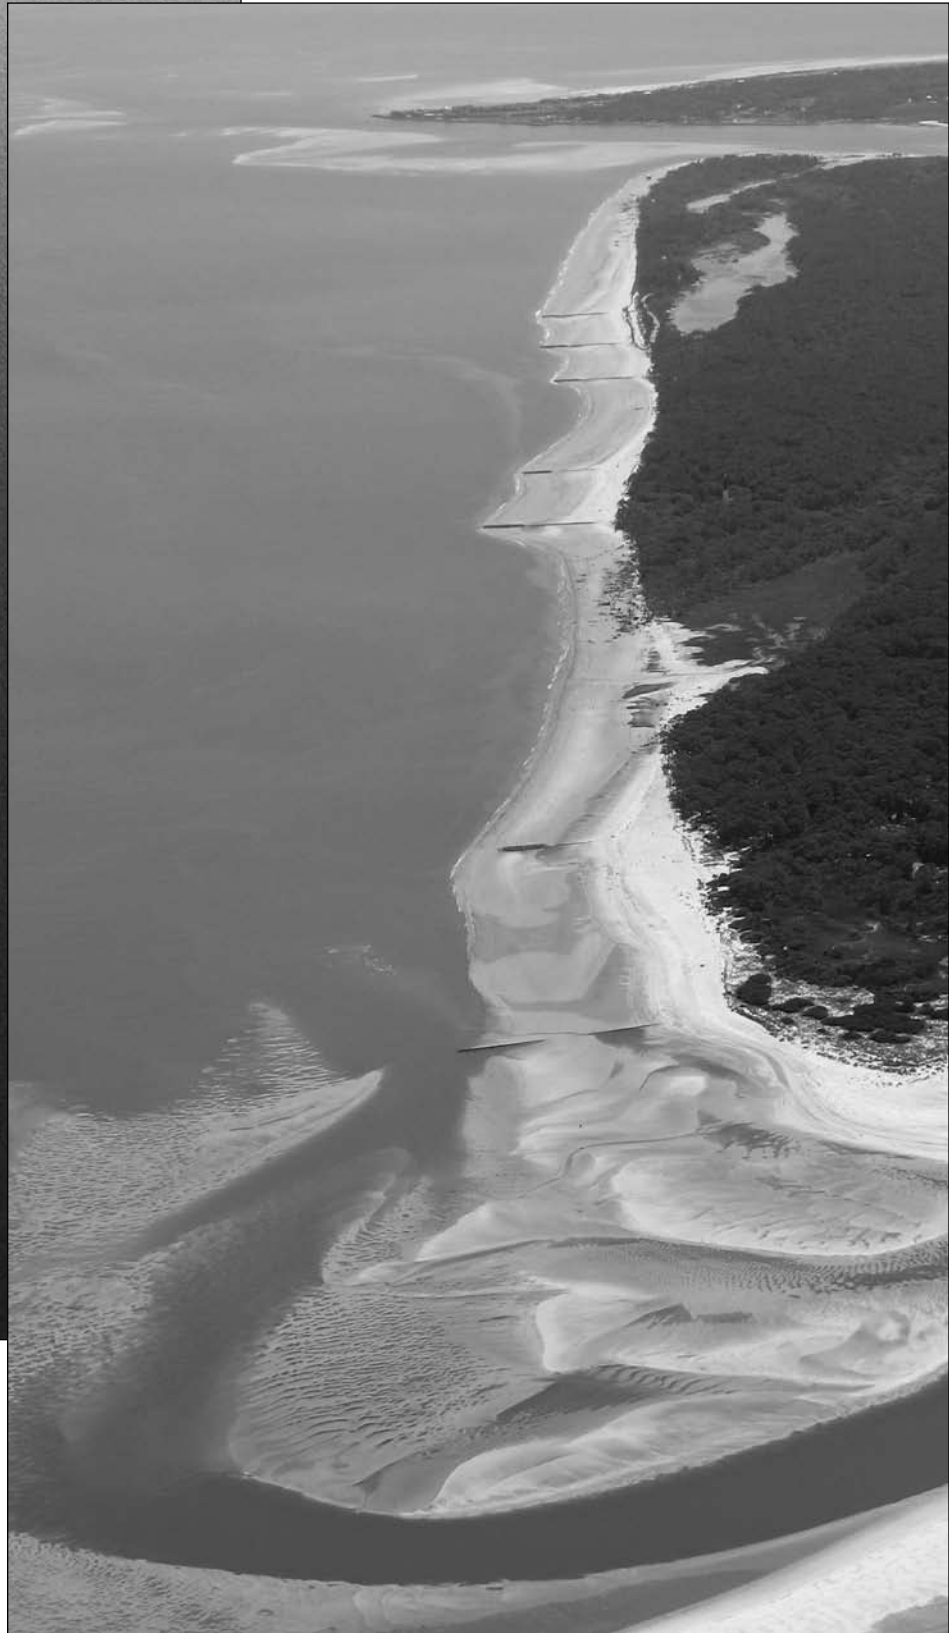
Figure 7. Before (looking north at low tide on 10 February 2006, left) and at present (28 April 2010, below, looking south) aerial images of the 2006-2007 nourishment and groin construction project at Hunting Island (SC). (Photos by CSE.)

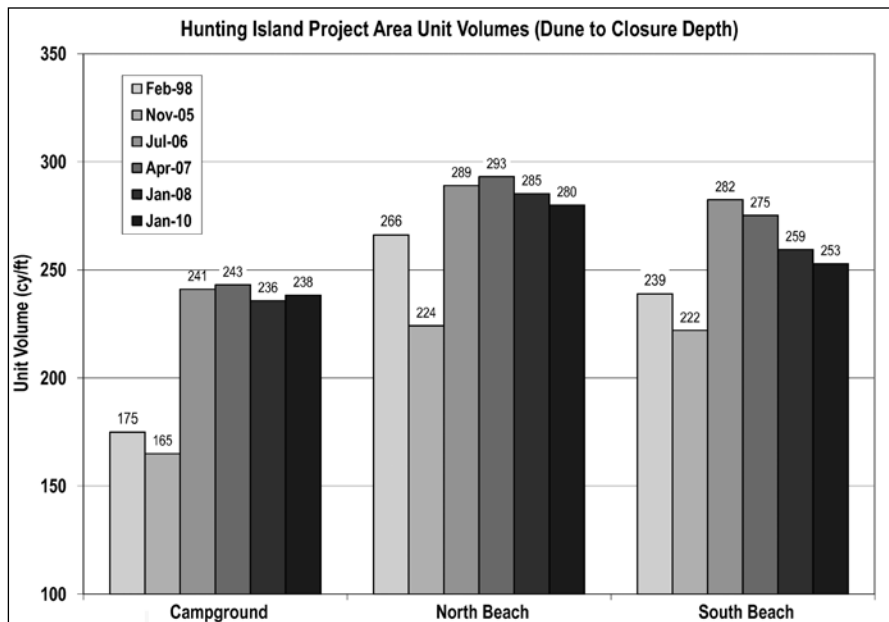
Figure 8. Project area unit volumes (cy/ft) since 1998. Nourishment occurred in spring 2006, and groin construction in January-February 2007. All project areas contain more sand than the 1998 condition. The South Beach reach shows the greatest erosion since groin construction, likely due to a lack of sediment supply as it is the updrift nourishment area.

The nourishment occurred between the November 2005 and July 2006 surveys; therefore, the volume change between these two surveys accounts for the cumulative effects of the nourishment and natural sand volume changes between these two dates. Unit volumes for the project areas are shown in Figure 8.

• **Area 1 (Campground)** lost ~9,600 cy (4.8 cy/ft) between April 2007 and January 2010. As of January 2010, the area retained ~96.3 percent of the ~152,000 cy gained from November 2005 to July 2006 (approximate nourishment volume).

• **Area 2 (North Beach)** lost ~32,900 cy (13.2 cy/ft) between April 2007 and January 2010. As of January 2010, Area 2 retained ~86.0 percent of the ~162,000 cy gained between the 2005 and 2006.

• **Area 3 (South Beach)** showed the greatest erosion, losing ~90,900 cy (22.3 cy/ft) from April 2007 to January 2010. As of January 2010, Area 3 retained ~51.1 percent of the volume gained from 2005 to 2006.

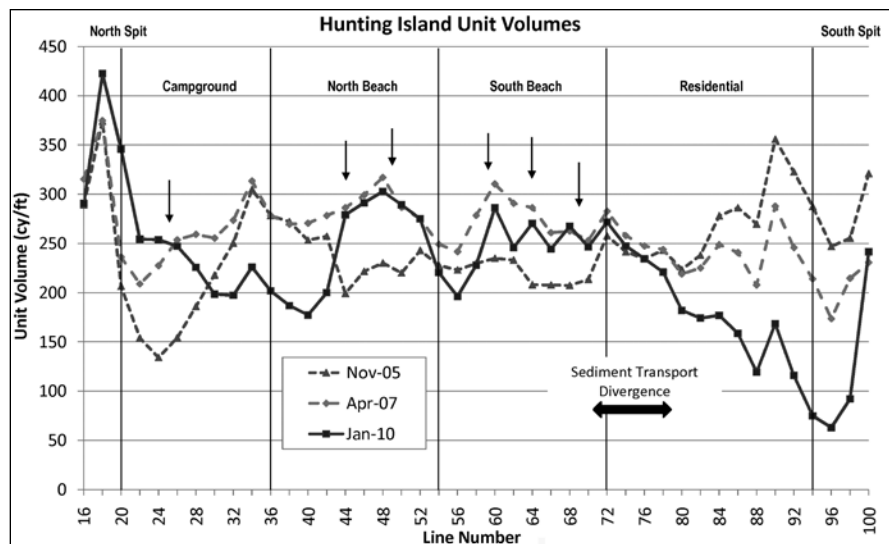
Figure 9. Unit volume change for monitoring stations along Hunting Island. Stations are spaced ~500 ft apart and are oriented perpendicular to the beach. Groin locations are indicated by the arrows. Note how the area between the Campground and North Beach showed erosion of up to 100 cy/ft following groin installation, whereas areas in the influence of groins showed much less erosion. Net northerly transport dominates along most of the island, reversing to the south around Stations 72 to 80.

When compared to sections of Hunting Island not protected by groins, the project areas show reduced erosion (Figure 9). Between April 2007 and January 2010, protected areas (updrift of groins) eroded an average of 13.1 cy/ft, while unprotected areas between project reaches eroded an average of 67.6 cy/ft. Overall, the northern two-thirds of Hunting Island (stations 16-72) has lost ~134,000 cy/yr since groin construction, which agrees well with the 150,000 cy/yr estimate presented in the downdrift impact analysis (CSE 2005).

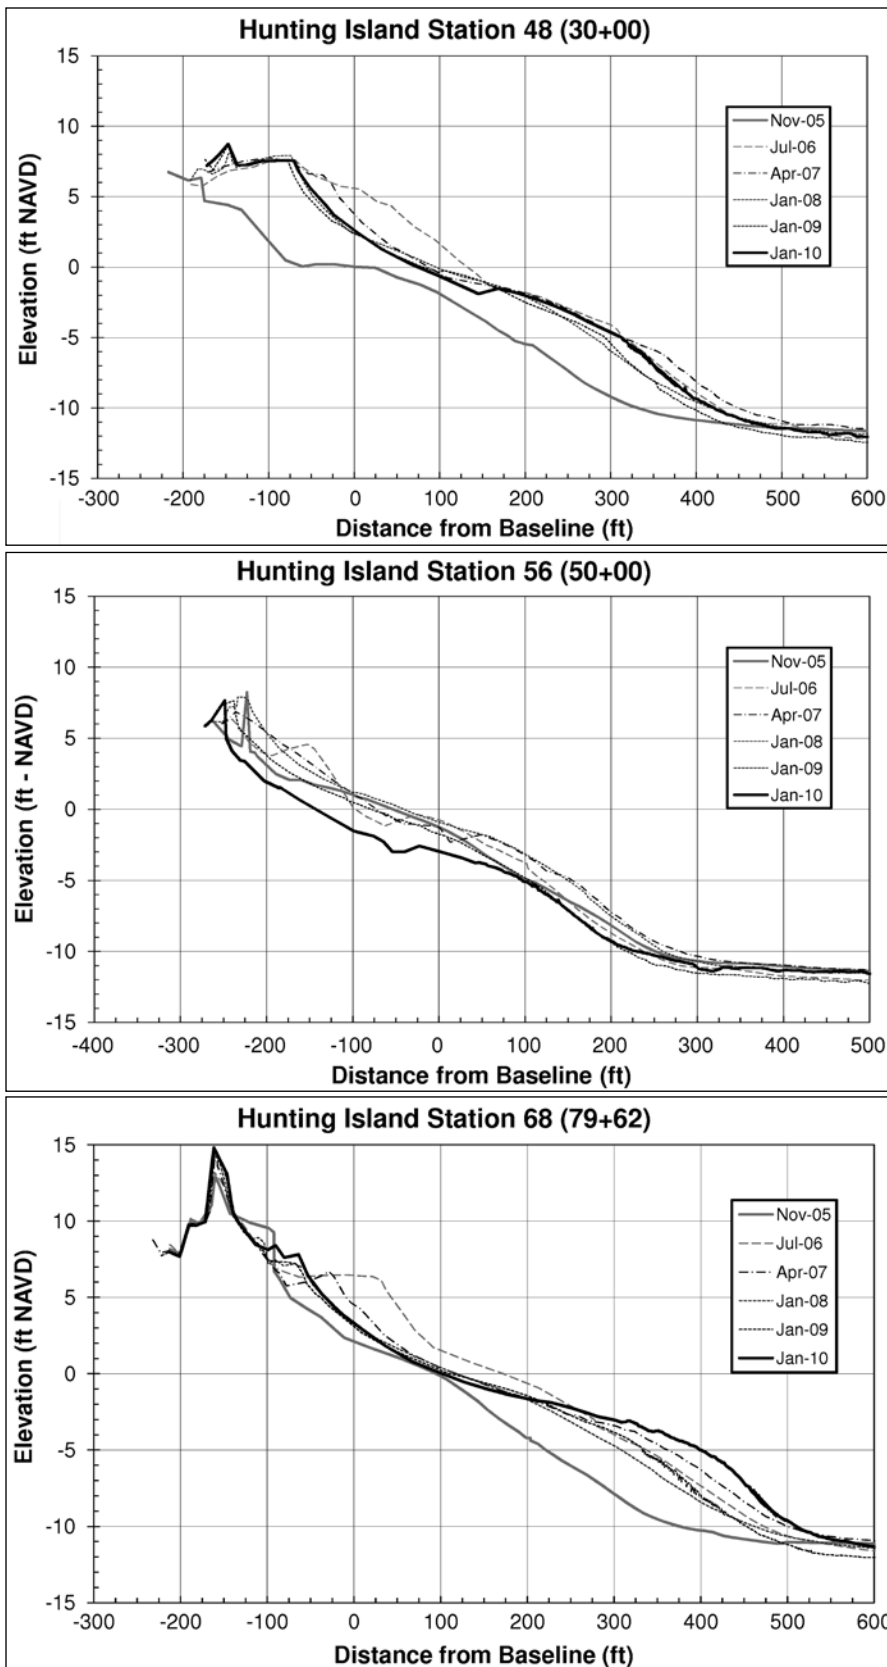
Figure 10. Profiles from Stations 48, 56, and 68. Stations 48 and 68 are in the North Beach and South Beach groin fields, respectively. Station 56 lies between the two groin fields. Note the relatively small change between the January 2008 and 2009 surveys at the protected stations, compared to the large change at Station 56, which is unprotected by groins. Nourishment occurred in spring 2006, followed by groin construction in January-February 2007.

unprotected areas, profiles from North Beach (Station 48), South Beach (Station 68), and the unprotected area between North Beach and South Beach (Station 56) are shown in Figure 10. From April 2007 to January 2010, the two stations protected by groins (stations 48 and 68) showed relatively little volume change (-14.2 and +4.8 cy/ft, respectively) and ~25 ft of reduction in beach width (at

the +5 ft NAVD contour). Station 56 (not protected by groins) showed much more erosion over the same period, losing 45.4 cy/ft and ~55 ft of dry beach width (at the +5 ft NAVD contour). Station 56 has eroded 16.4 cy/ft/yr following groin construction, compared to 9.6 cy/ft/yr between 1998 and 2004. This increase may be due to sediment trapping of the updrift groin field; however, island-wide

One important aspect of the data shown in Figure 10 is that profiles in the influence of the groins are maintaining the lower beach profile (below mean low water [MLW]), which serves as a foundation to the visible beach (above MLW). As long as the lower portion of the profile remains stable, the exposures of the groins will be reduced, because the remainder of the visible beach necessarily maintains certain limiting slopes. This is also expected to improve aesthetics (Gomez-Pina 2004) and leave the upper beach better protected from erosion during storm events.

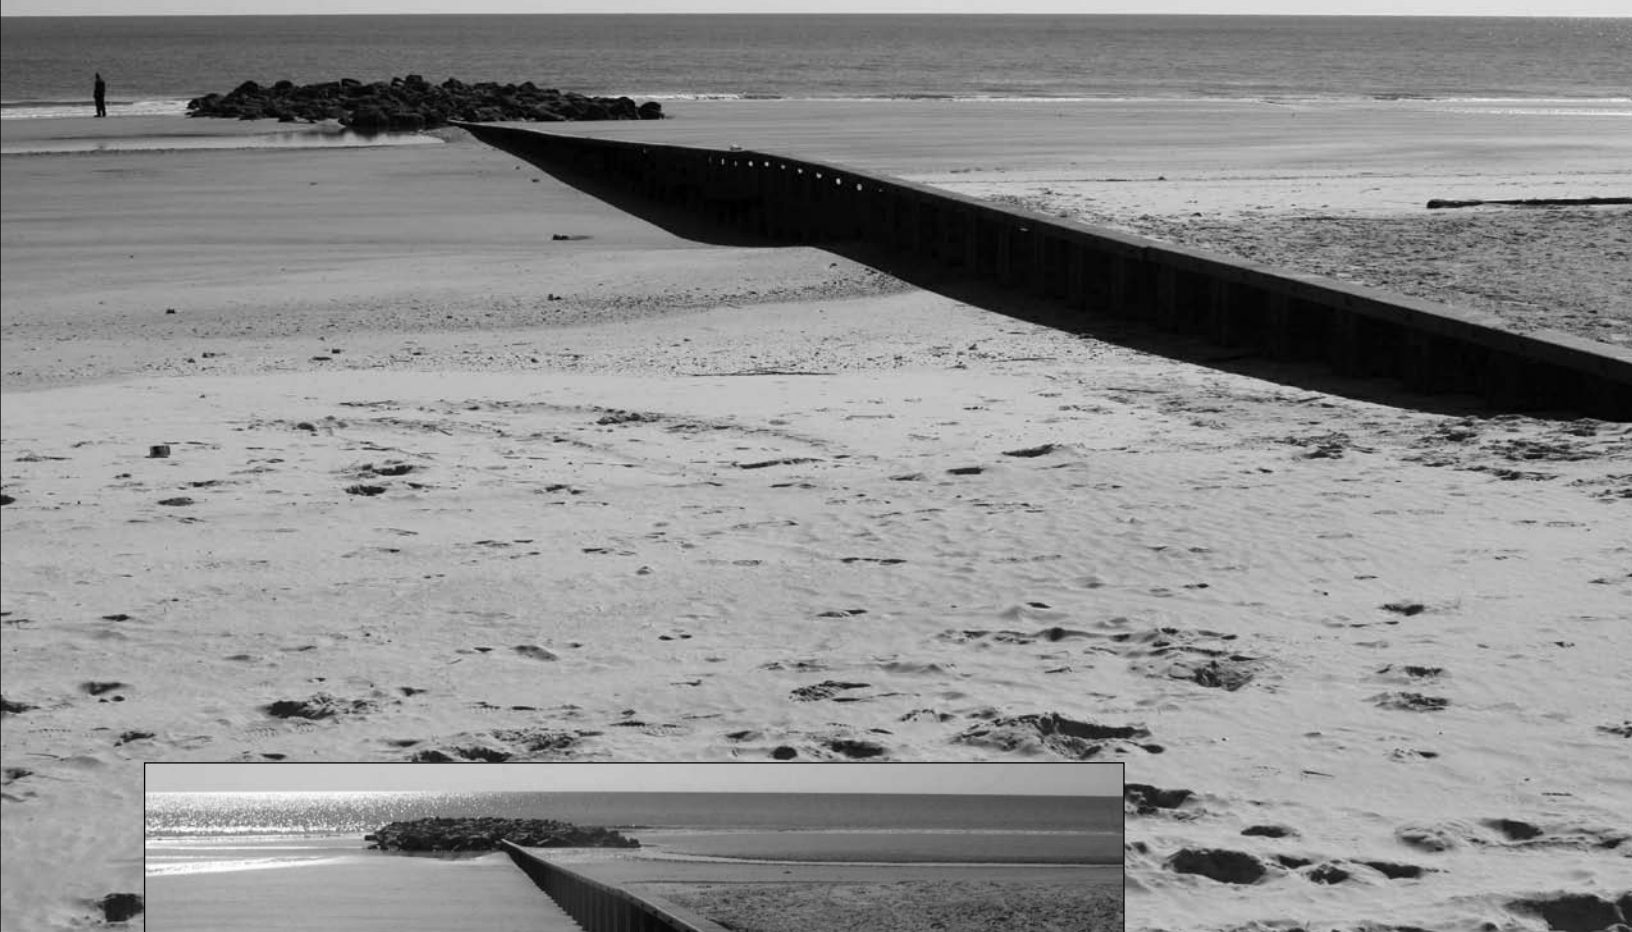
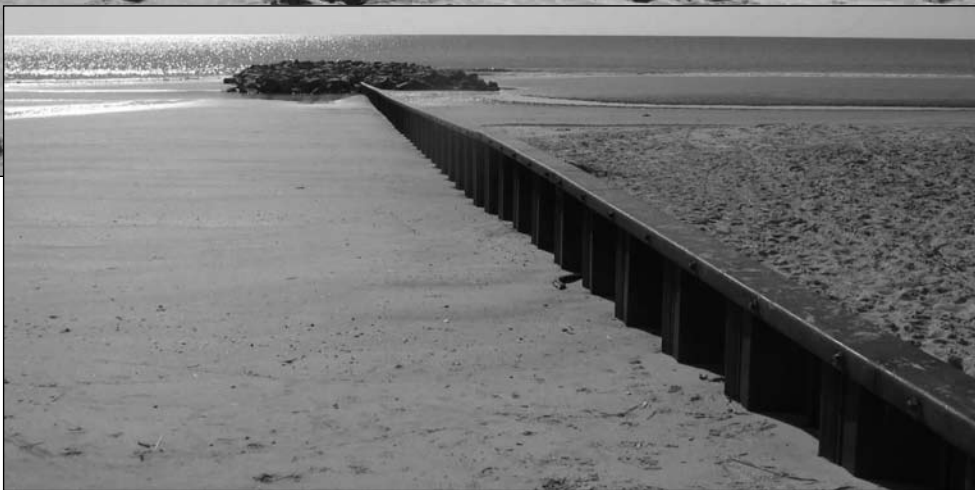
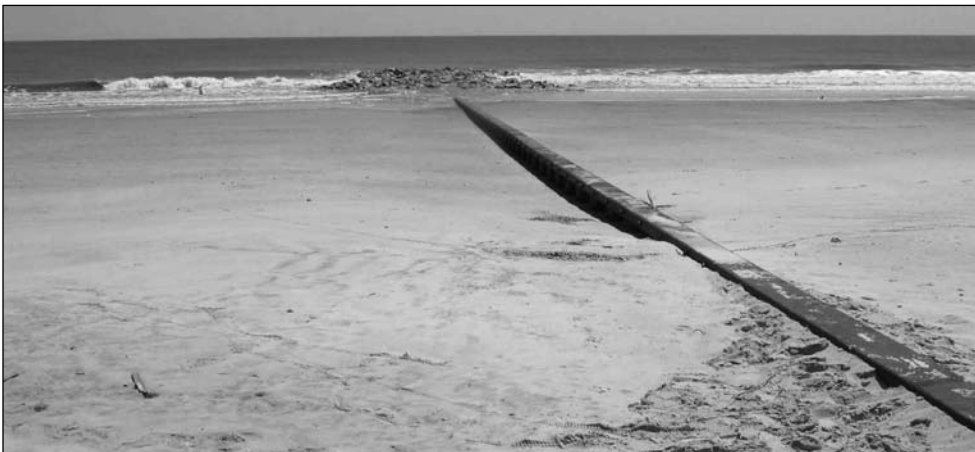
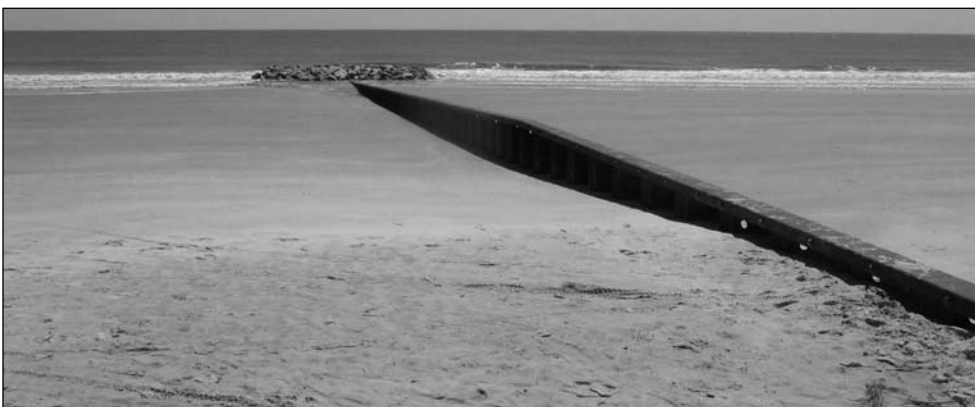
Figure 11. Post-project (April 2007) and January 2009 images of Groin 4 (upper) and Groin 7 (lower). All groins maintain a relatively low exposure (less than 4 ft), which was one of the goals of the project. “Template” groins, which slope to match the natural profile of the beach, are thought to maintain a lower reveal and offer better performance in the lower beach profile compared to most groins constructed in earlier decades, which often had little slope and terminated landward of the low-tide line.

The groins showed relatively low reveal along their profiles after three years (Figure 11). The maximum exposure (~3.5 ft) was found along the north side of Groin 8. (Note the south side showed up to ~3 ft of reveal.) The degree of reveal diminished to the north with most of Groin 1 being buried in January 2009.
